HISTORIC RESOURCES INVENTORY

- 1. Common name: P.G. and E. Office
- 2. Historic name: Westinghouse Barn
- 3. Street or rural address: 655 Miramontes
City Half Moon Bay Zip 94019 County San Mateo
- 4. Parcel number: 056-173-150
- 5. Present Owner: Eriksen Cendalie Ebnetter Address: 1335 Yosemite
City San Francisco Zip 94124 Ownership is: Public _____ Private X
- 6. Present Use: Office Original use: Barn

1. Common name: Methodist Church
2. Historic name: Methodist Episcopal Church
3. Street or rural address: Miramontes Street, (northeast corner w/ Johnston)
City Half Moon Bay Zip 94019 County San Mateo
4. Parcel number: 056-177-005⁰⁵⁰
5. Present Owner: Community Methodist Church Address: 777 Miramontes
City _____ Zip _____ Ownership is: Public _____ Private X
6. Present Use: Church Original use: Church

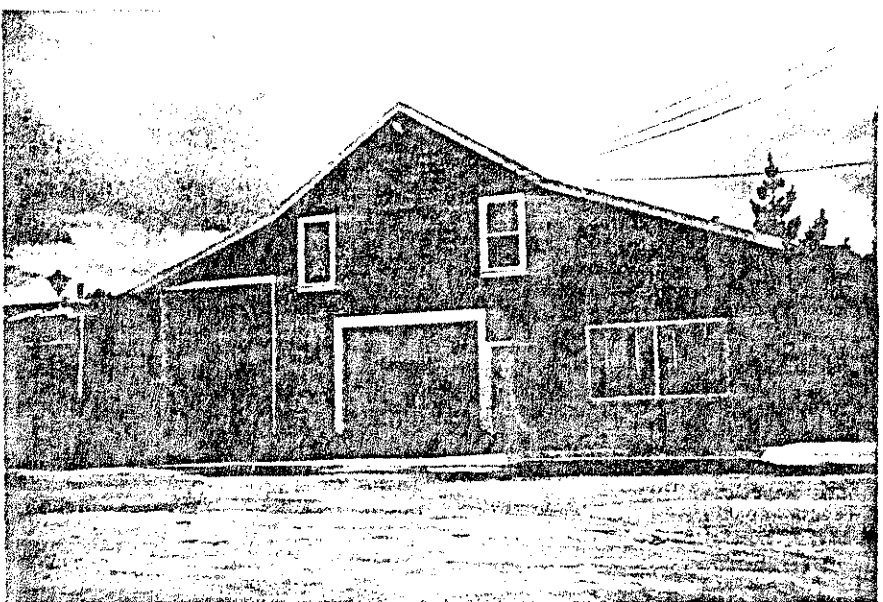
655 Miramontes is a wooden two story barn that P.G.E. has converted into an office building. The style is a vernacular Western Barn form which is distinguished by its distinctive roof pitch. The gable end with block and tackle face Purissima Street. Pent roofs cover shed roof additions on the north and south elevations. Six over six double hung sash windows with simple frames flank the second story loft opening. Wide ship lap siding covers the structure.

The ground floor has been altered with large opening, a door and modern window forms. Company vehicles are kept in a lot to the left of the building. Landscaping is minimal consisting of two large junipers on the facade. The building is in excellent condition.

13. Condition: Excellent Good _____ Fair _____ Deteriorated _____ No longer in existence _____
14. Alterations: First floor windows and the two large entry doors
15. Surroundings: (Check more than one if necessary) Open land _____ Scattered buildings _____ Densely built-up _____
Residential Industrial _____ Commercial _____ Other: _____
16. Threats to site: None known Private development _____ Zoning _____ Vandalism _____
Public Works project _____ Other: _____
17. Is the structure: On its original site? Moved? _____ Unknown? _____
18. Related features: _____

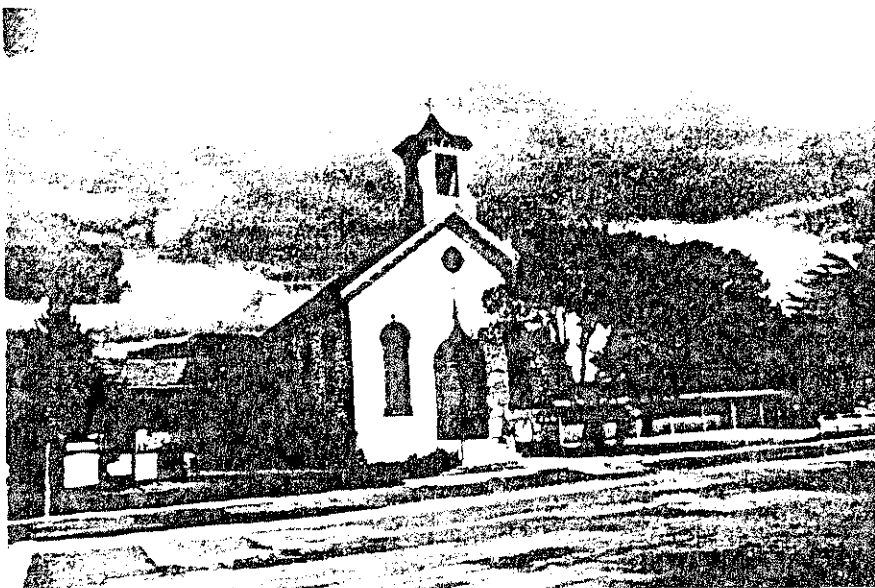
One-story in height, the Methodist Chrch is sheathed in shiplap siding and has a gabled roof. A belfry sits atop the roof at the buildings facade and is octagonal in shape with cut out sections exposing the bell to full view. A small cupula tops the belfry and contains decorative brackets under the eaves. Additional brackets may be seen under the buildings eaves on all sides. Most notable in the church design are the lancet windows with rounded arch above and small wooden cross. Each windows contains a carved letter "M", perhaps a hint at the craftsman's identity. There are four windows on each side elevation and two at the facade which flank a centrally located double door. A fanlight above the door sits under a wood carved ogee arch. The building is in excellent condition.

A small one-story addition is located at the west elevation of the Church and is today used as a social hall. Also sheathed in shiplap siding, this addition was at one time a part of the Ocean Shore Railroad Station in Half Moon Bay. Date of move to this site is not known.

13. Condition: Excellent Good _____ Fair _____ Deteriorated _____ No longer in existence _____
14. Alterations: social hall addition remodeled. wing attached 1991
15. Surroundings: (Check more than one if necessary) Open land _____ Scattered buildings _____ Densely built-up _____
Residential Industrial _____ Commercial _____ Other: _____
16. Threats to site: None known Private development _____ Zoning _____ Vandalism _____
Public Works project _____ Other: _____
17. Is the structure: On its original site? Moved? _____ Unknown? _____
18. Related features: Social hall, once railroad depot and mature vegetation
